Home Inspection Consultants Inc.

Confidential Inspection Report Sample Amherstburg, ON

May 10, 2018

Inspection Table of Contents

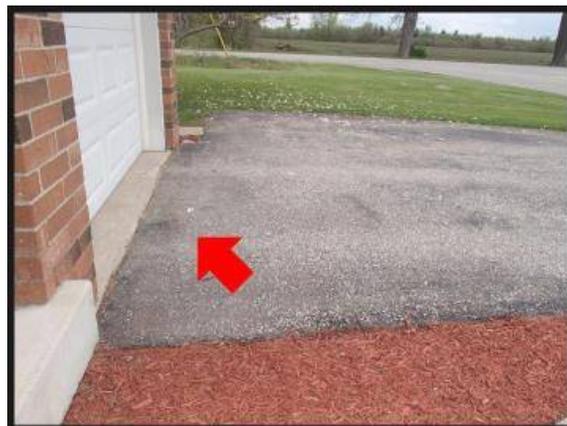
As discussed on site, an area of the driveway slopes towards the garage and this should be monitored and corrected as necessary to deter moisture issues.

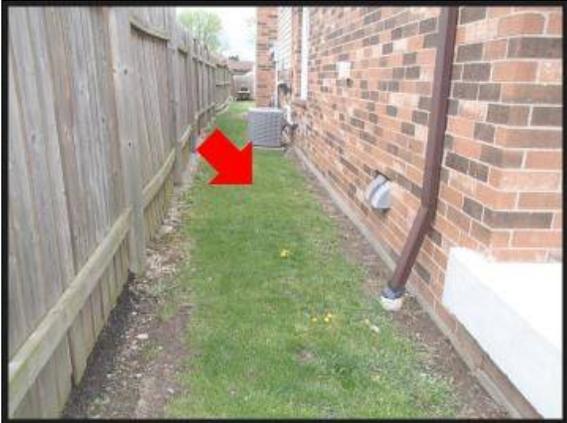
As discussed on site, some areas of the grade slope towards the foundation and this should be corrected to deter water penetration in the home. The grade should slope away from the foundation.

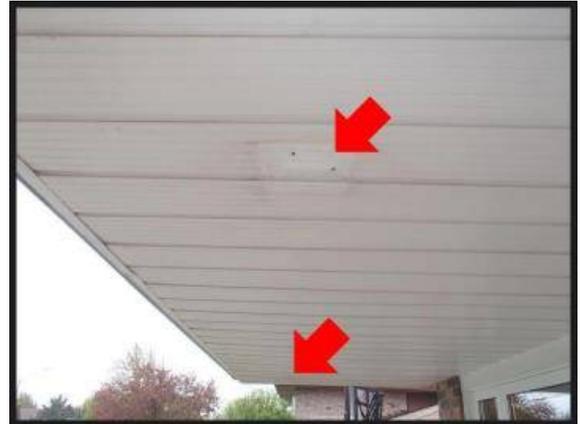
The support pillars have been removed as it appears that the concrete deck has been upgraded. Since the roof structure is trusses, vertical posts are not essential. However, it is advised that one of the three posts that was removed be replaced to ensure structural integrity.

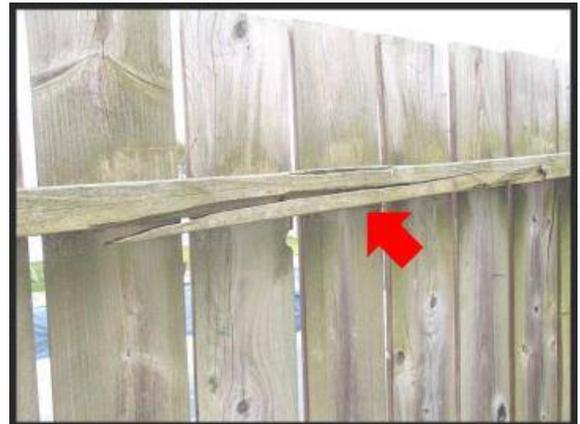
The fence is older and requires some repairs.

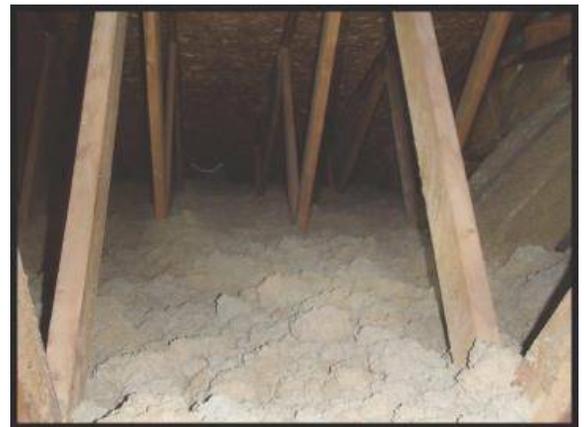
The upper attic could not be inspected due to inaccessibility and therefore its condition is excluded from this report. This attic should be inspected.

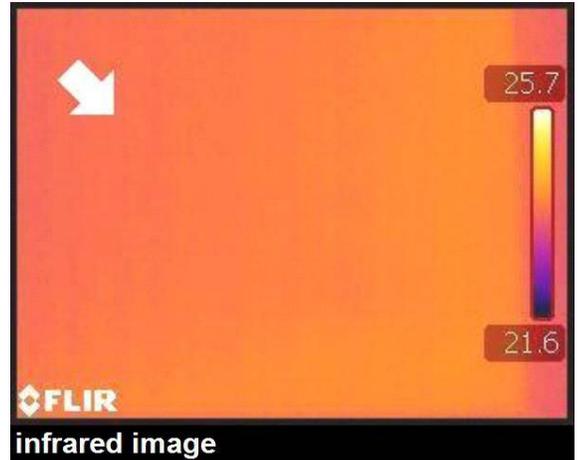
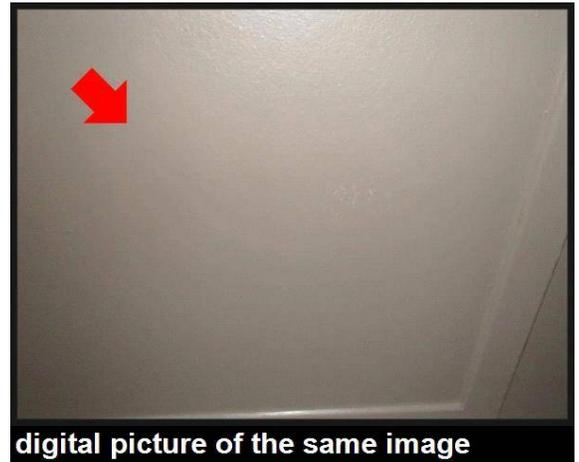
For better energy efficiency, the access door requires insulation. The lighter colours in the infrared images indicate warmer temperature readings which may indicate missing insulation.

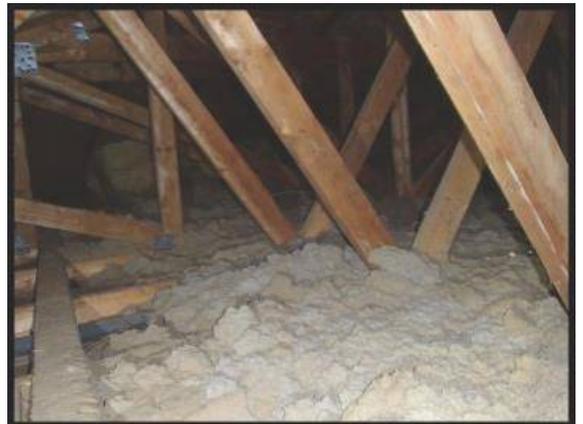
The insulation is approximately R-28 and it should be upgraded for improved energy efficiency. Added insulation will make the home cooler in the summer and reduce heat loss in the winter. The current standard for insulation is R-50.

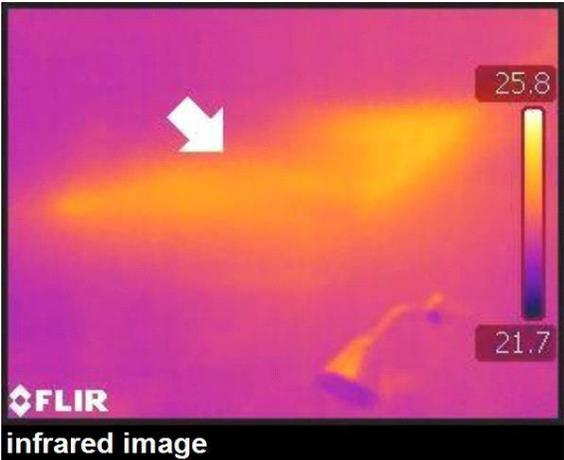
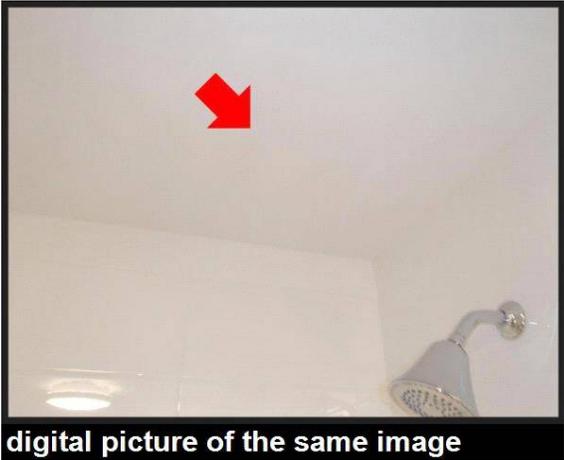
There are areas that are void of insulation. This should be corrected as the insulation should be even throughout for better efficiency. The lighter colours in the infrared images indicate warmer temperature readings which may indicate missing insulation.

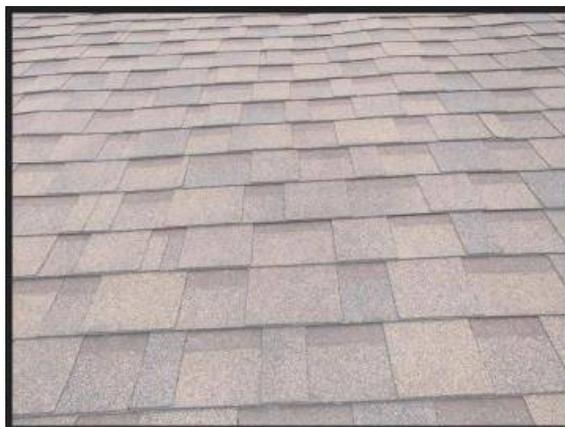
As discussed on site, the top layer of roofing material is older and near the end of its life expectancy.

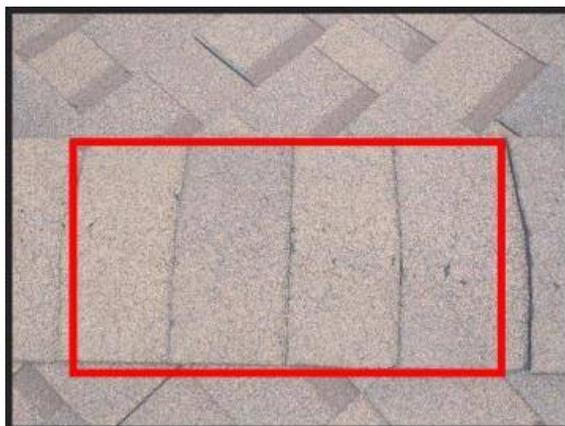
There is a loss of granules on the ridge/hip capping exposing the shingle backing and this should be monitored.

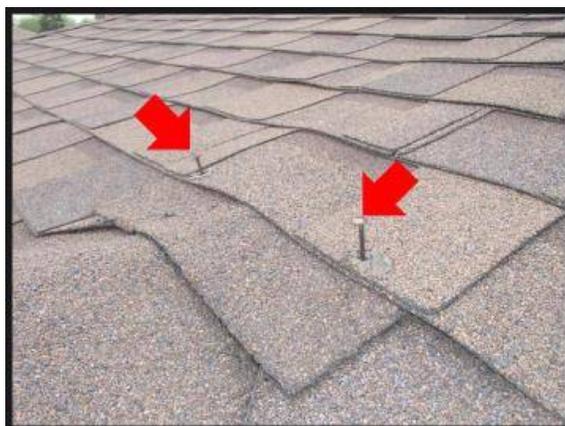
The exposed fasteners should be secured/sealed to deter water penetration/damage.

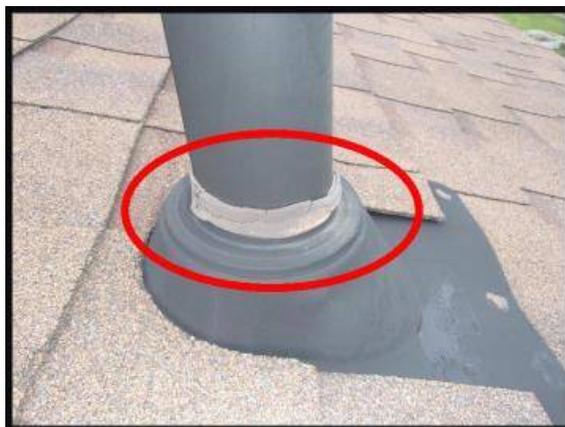
To deter moisture issues, added sealant is required at the plumbing vent.

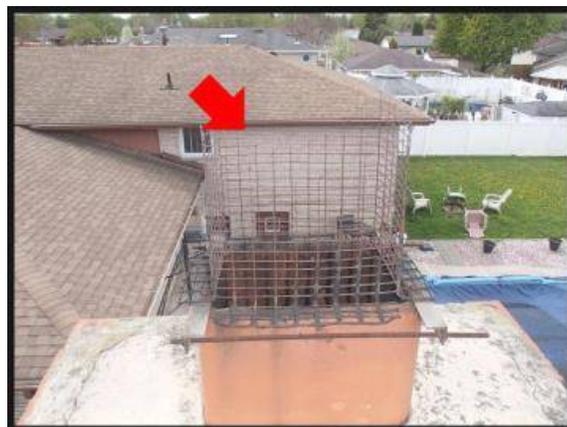
The rain hood is missing and should be replaced to deter animals/rain from entering the home. The hood also deters embers from a wood fire from becoming airborne.

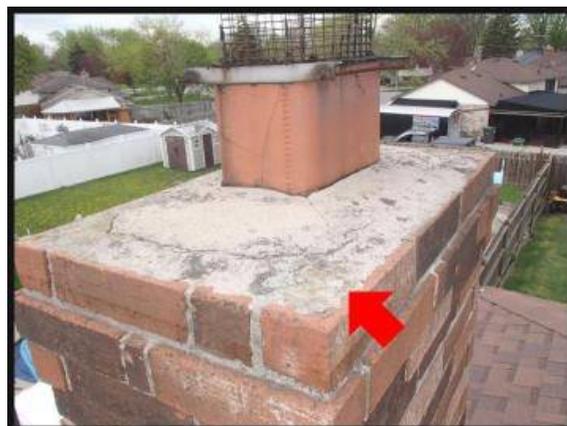
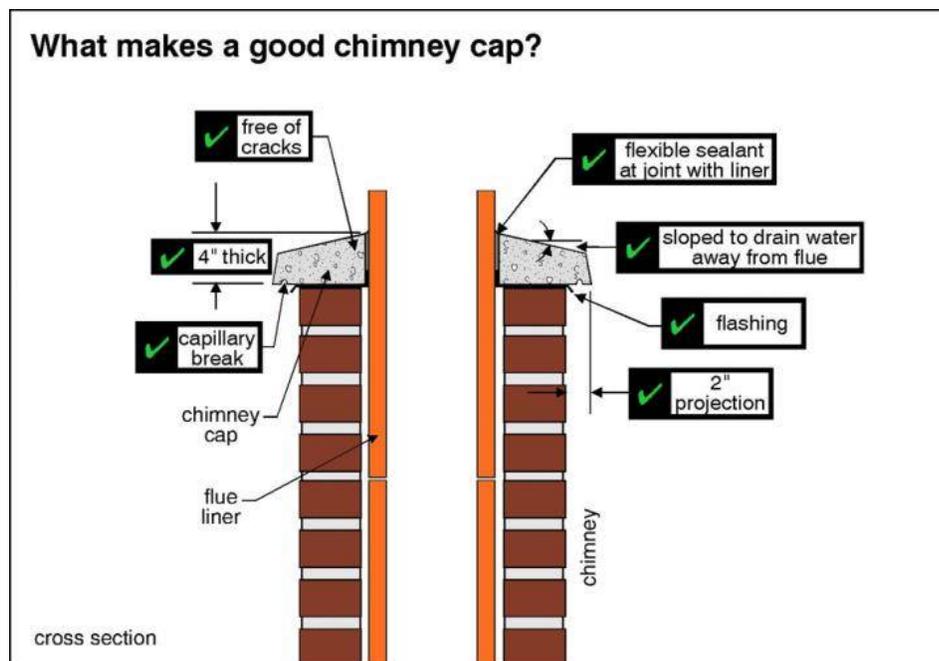
As discussed on site, the rain/drip cap to the chimney is worn/cracked and it should be repaired/replaced as necessary. The role of the rain/drip cap is to deter moisture from entering the chimney and to deter breakdown of the chimney components.

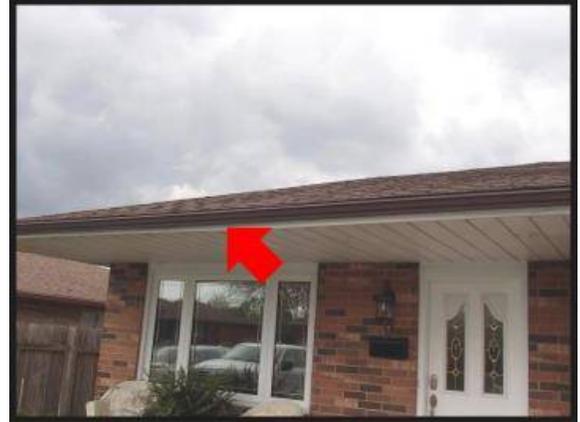
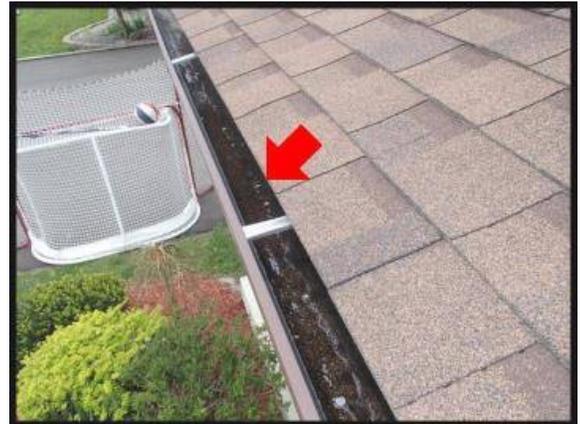
Although the eaves trough is generally in fair condition, a portion of the eavestrough requires re-aligning as it is holding water.

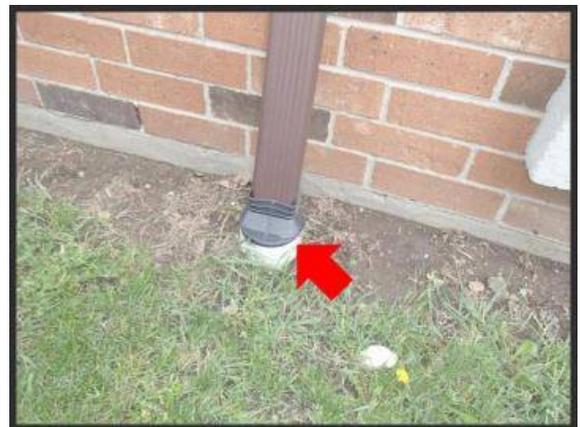
Some of the downspouts drain into the ground and this may not be reliable for water control ie. water may enter the basement/home. The downspouts should be disconnected from the ground and the water run-off should be directed at least 6 to 8 feet away from the foundation. Downspouts that discharge below grade are more likely to cause basement leakage or foundation damage due to clogged or deteriorated pipes. Disconnecting downspouts to redirect discharge above grade is a preventative measure to reduce the risk of foundation leakage and structural damage. Please note that depending on the age and installation, concealed water damage may have already occurred.

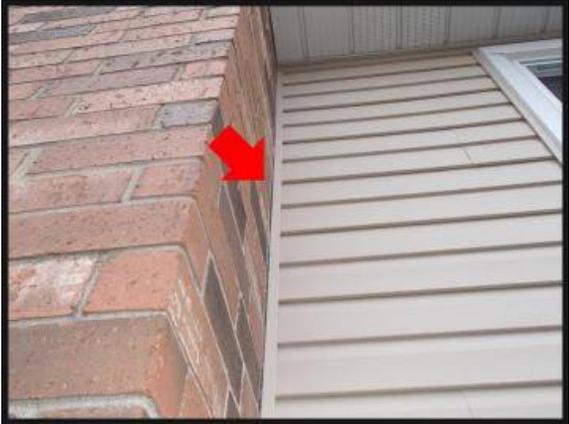
Sealant is recommended where the siding meets the brick walls to render these areas weather-tight.

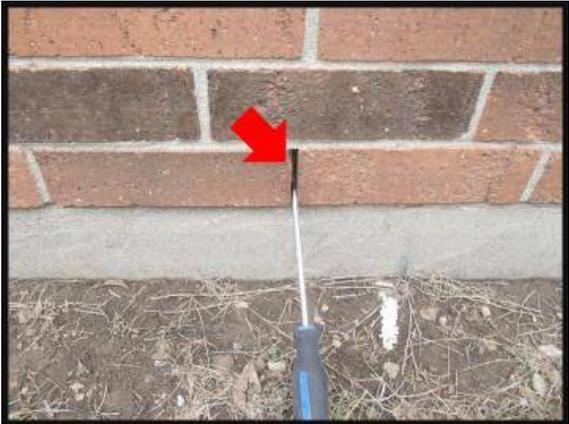
Screens or non-corrosive steel wool should be installed in the weep holes to deter insects from entering the home. Weep holes are necessary to drain water and act as a venting device for the air space in the wall.

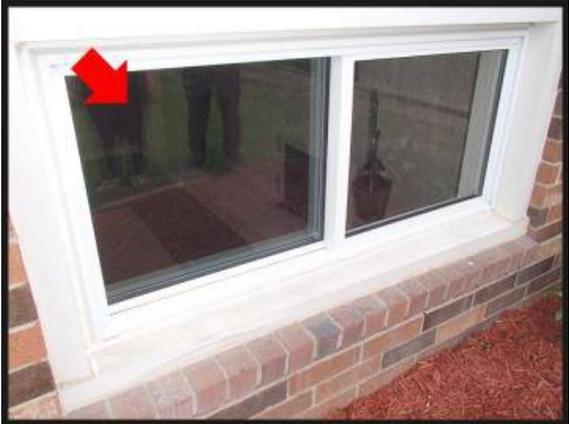
The are missing screens for the windows and this should be assessed further with the seller.

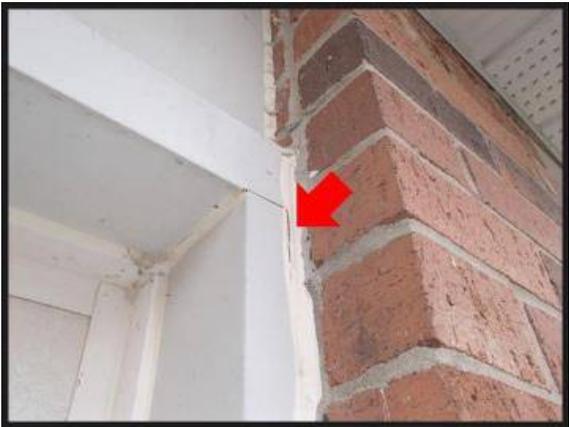
As discussed on site, the exterior of some of the windows requires sealant in order to deter water penetration/damage and/or air intrusion.

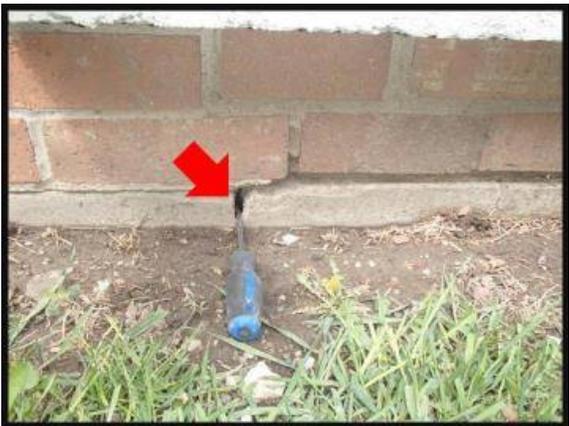
As discussed on site, the foundation requires some repointing in order to help stabilize and seal the foundation.

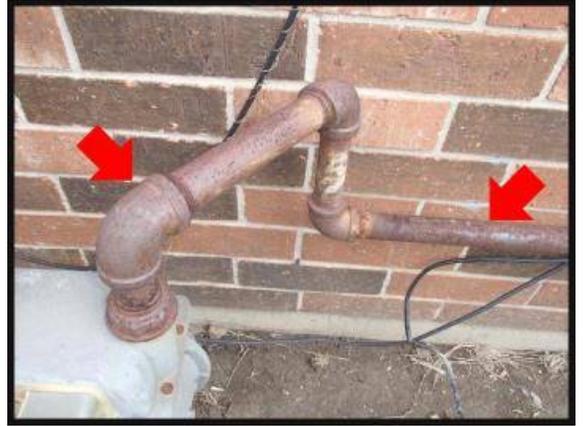
There is rust on the steel gas pipe and this should be treated/sealed to deter further rusting.

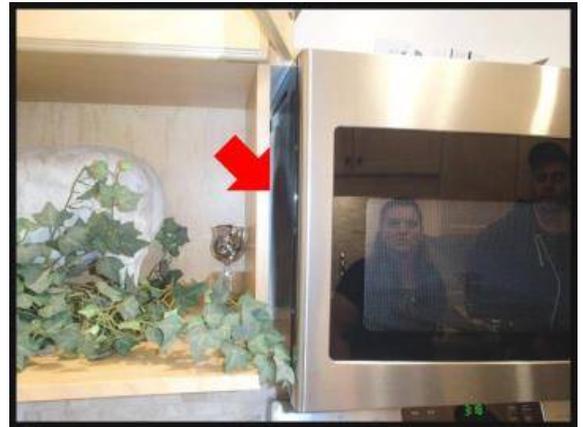
Sink: The sink(s) is generally in fair condition.
Counters: Counters are generally in fair condition.
Cabinets: Cabinets are generally in fair condition.
Exhaust Fan: There is air loss and this should be corrected for proper venting.

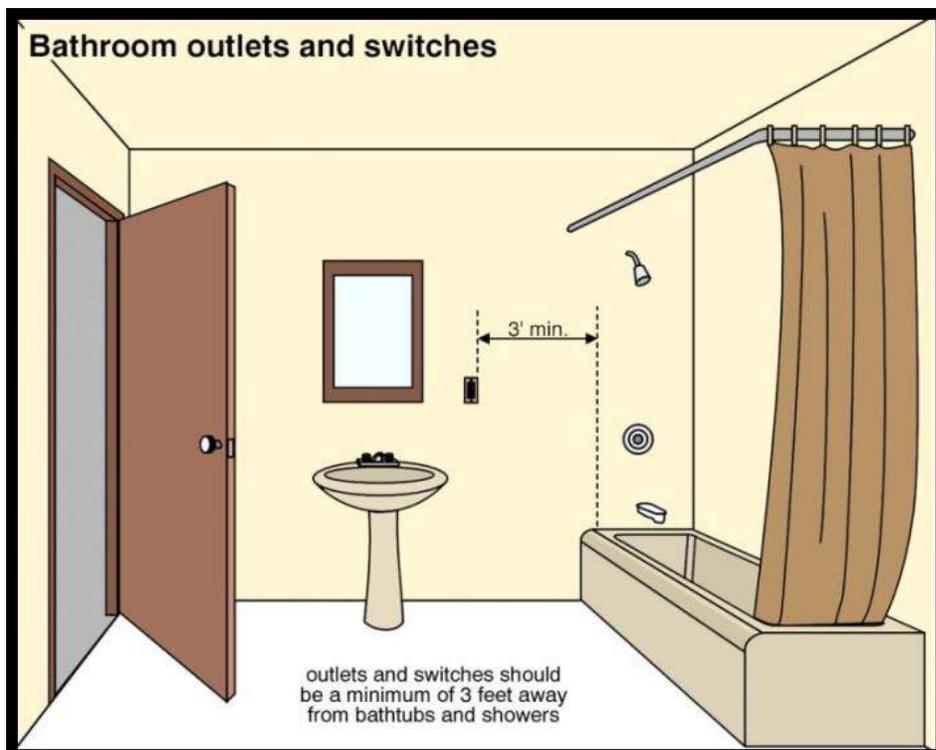
The light switch is located too close to a source of water and this should be corrected for safety.

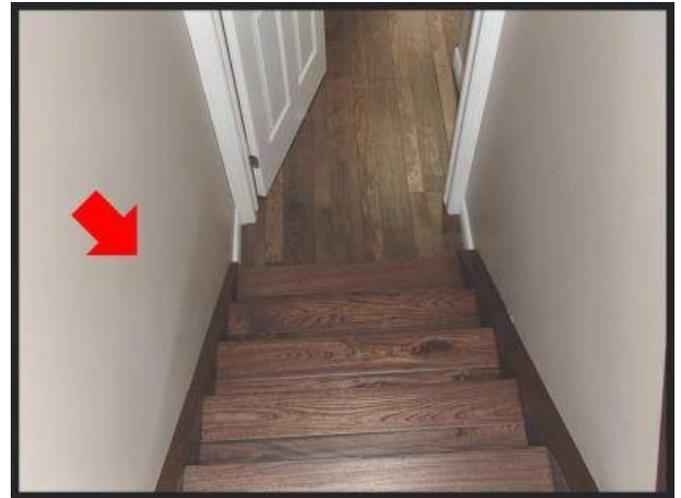
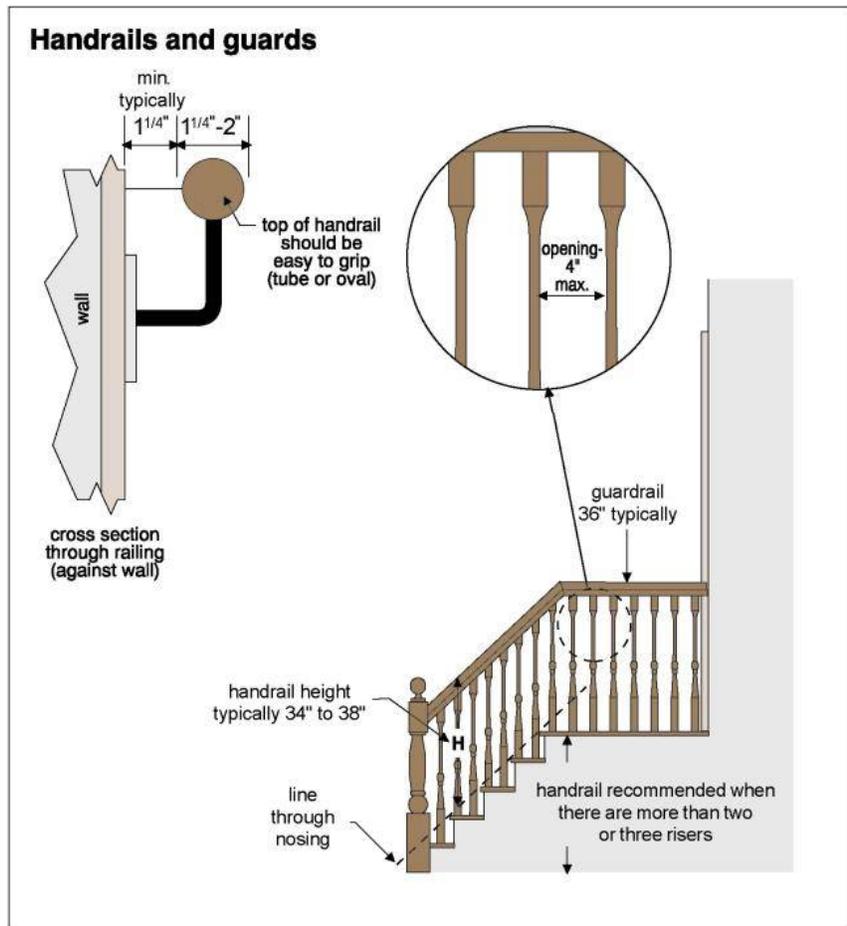
The lower stairs are in fair condition. However, for safety, the lower stairs require a handrail.

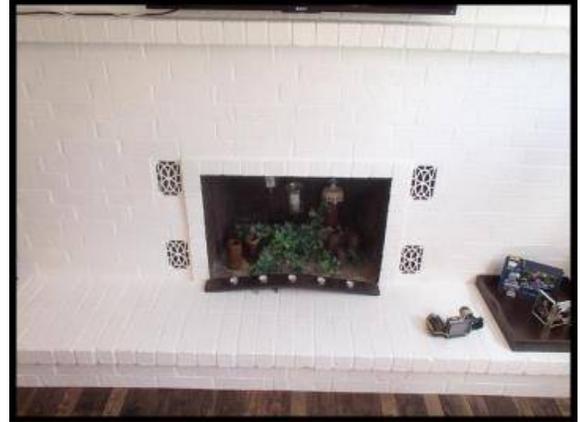
Wood-burning Masonry Fireplace: As discussed on site, for safety the wood-burning fireplace should not be used until it is certified by a WETT technician. The chimney and firebox should be cleaned and inspected for safety.

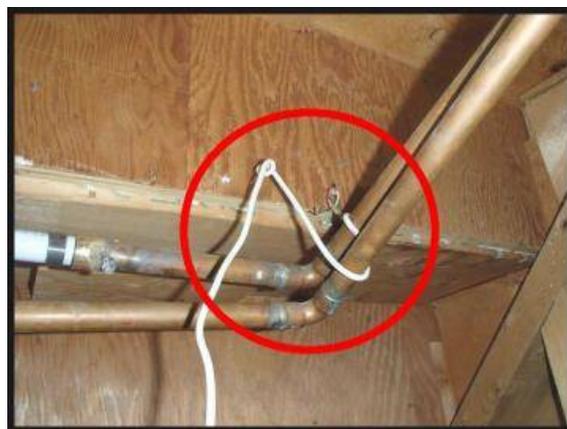
The copper water supply lines should be supported with non-metallic or compatible metal straps to prevent corrosion.

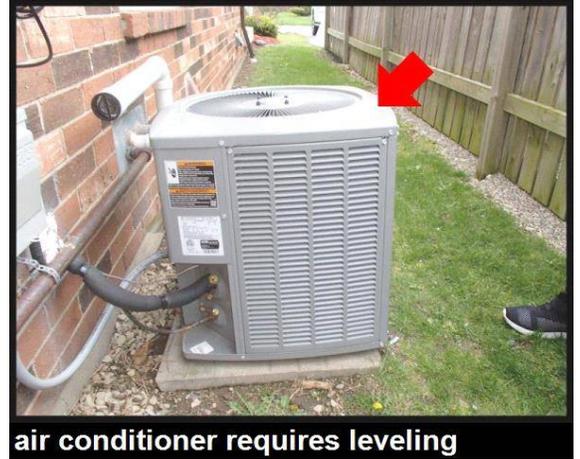
The air conditioner requires leveling in order to function as designed.

air conditioner requires leveling

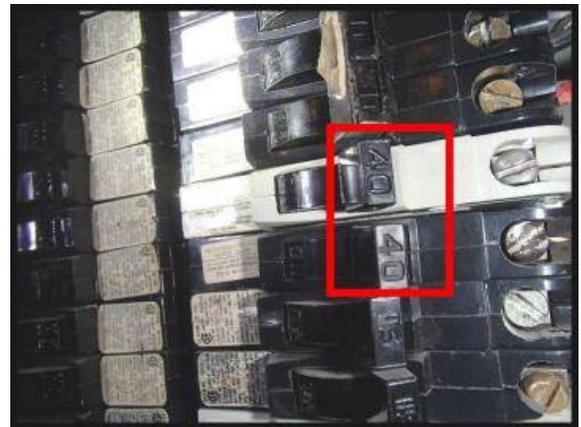
A tie bar is missing and this should be corrected for safety. A tie bar is required so when a circuit breaker trips during an overload, the connected circuit breaker will also trip ensuring that no power remains to the fixture or appliance.

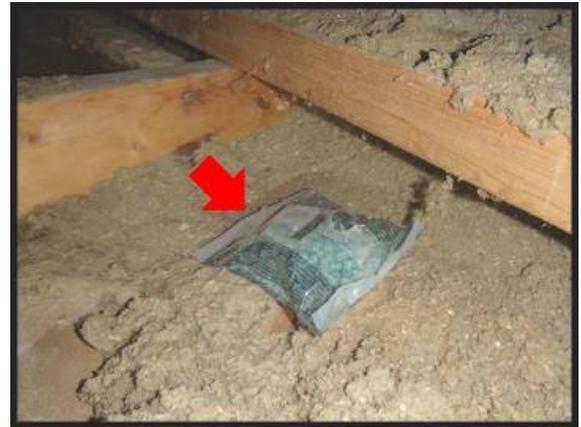
As discussed on site, there is evidence of rodents in the home. The inspection for rodents does not form part of this inspection and therefore it is recommended that a pest control company assess this further. Rodents/animals can cause damage to electrical wiring and to other building components. The extent of any damage caused by rodents is unknown and cannot be determined by this visual home inspection.

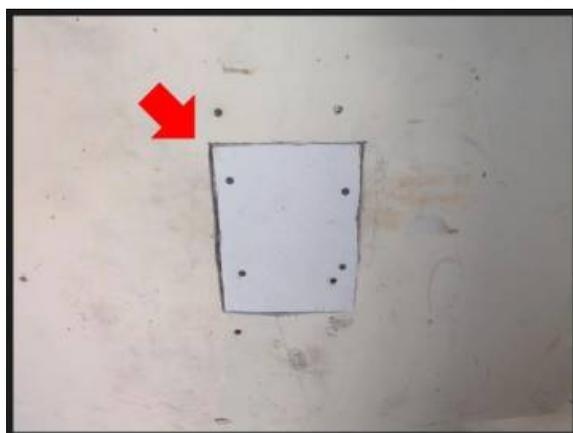
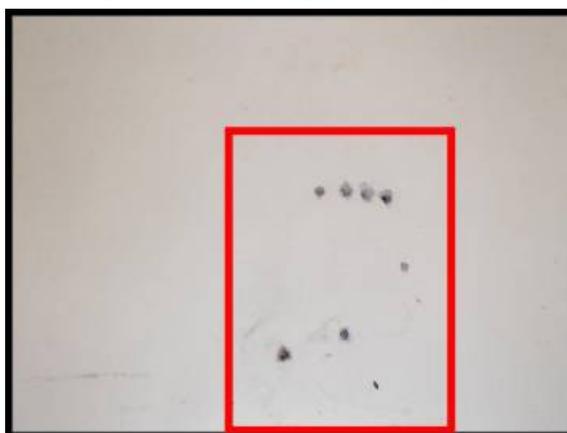
For safety, all openings in the separation wall should be repaired/sealed with approved materials in order to have a proper separation between the garage & the dwelling and to deter potentially hazardous gases from entering the dwelling.

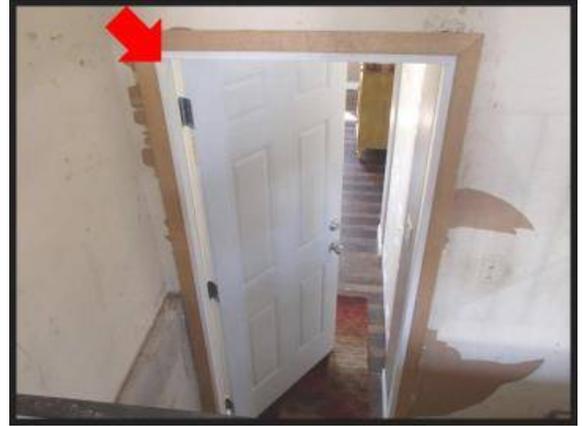
In order to deter toxic gases from entering the dwelling, an automatic door closure is required on the separation door and sealant is required along the garage-side of the door trim for safety.

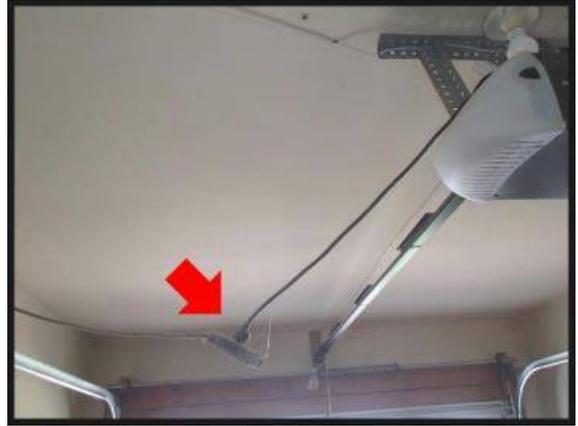
The garage door opener should have a receptacle located next to the opener. The use of extension cords is not recommended.

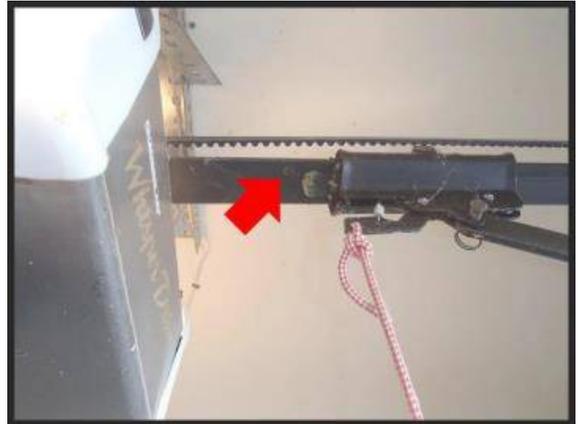
A safety bolt is recommended to help deter mechanical damage to the opener.
