Home Inspection Consultants Inc.

Confidential Inspection Report Sample Amherstburg, ON

May 10, 2018

Inspection Table of Contents

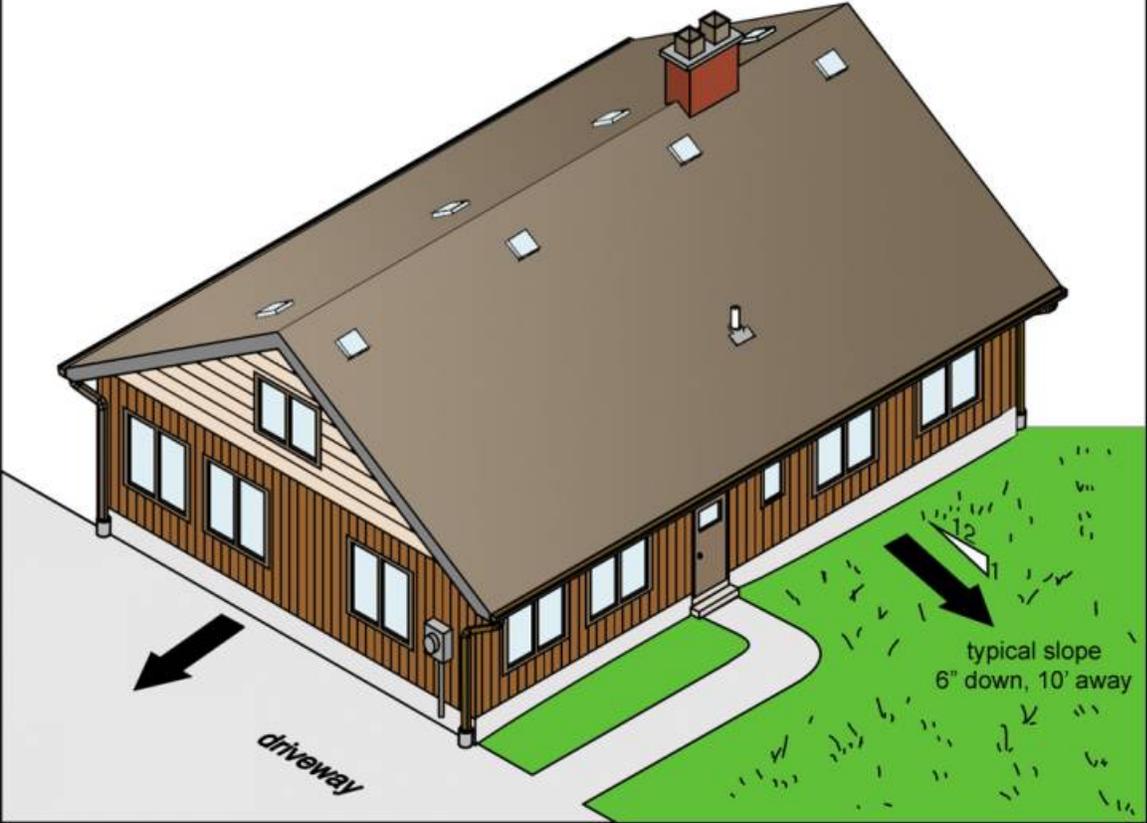
As discussed on site, some areas of the grade slope towards the foundation and this should be corrected to deter water penetration in the home. The grade should slope away from the foundation.

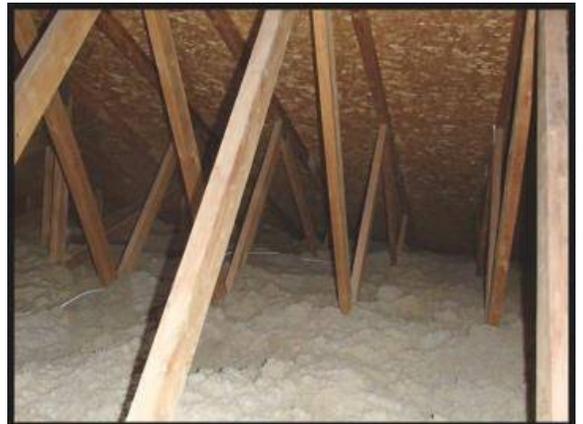
Insulation Condition:

The insulation is approximately R-28 and it should be upgraded for improved energy efficiency. Added insulation will make the home cooler in the summer and reduce heat loss in the winter. The current standard for insulation is R-50.

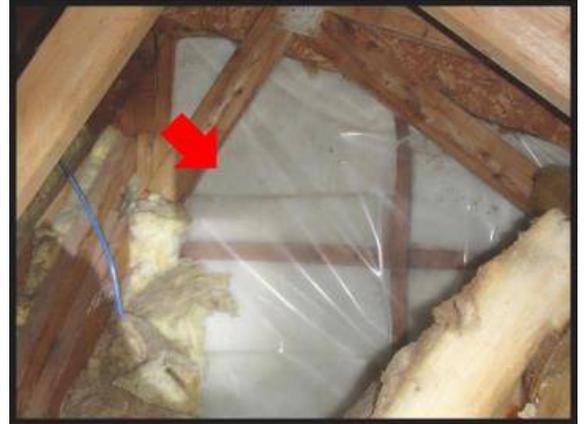
The vapour barrier to a section of the wall is installed on the wrong side of the attic as it should be installed on the warm side of the attic.

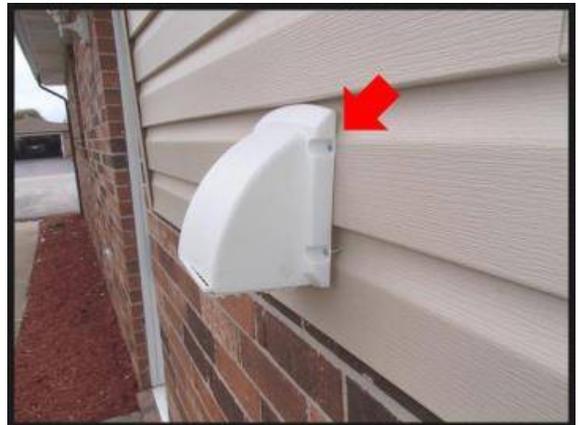
Observations:

All openings passing through the exterior walls should be sealed to ensure that the walls are weather-tight.

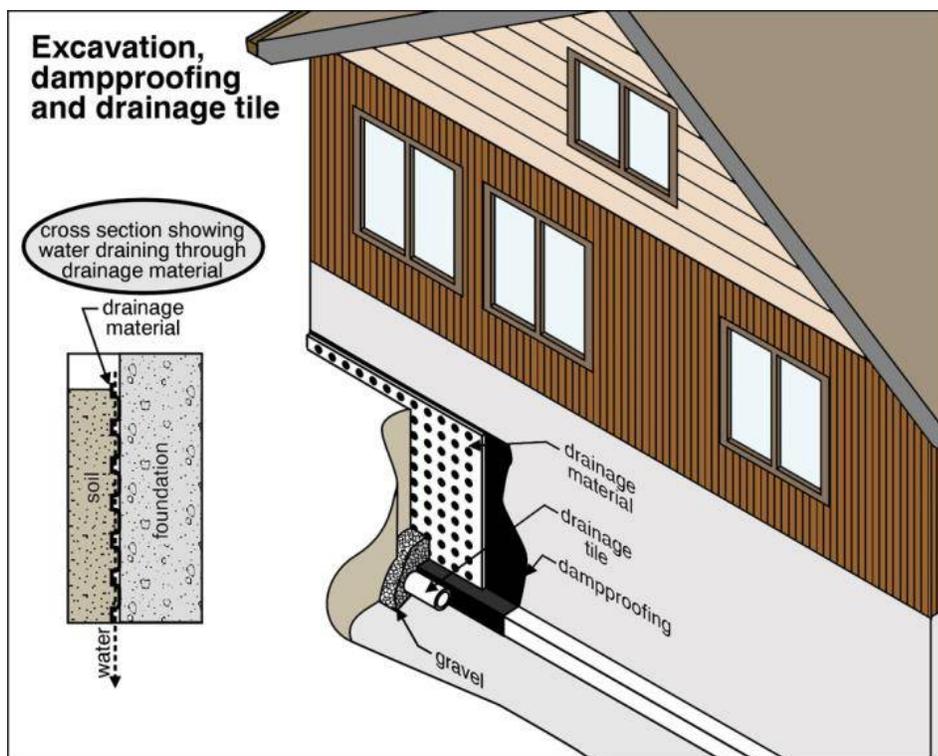
Waterproof Membrane:

Since there is no water proofing membrane noted at the foundation, this should be monitored as the foundation may be more vulnerable to moisture intrusion.

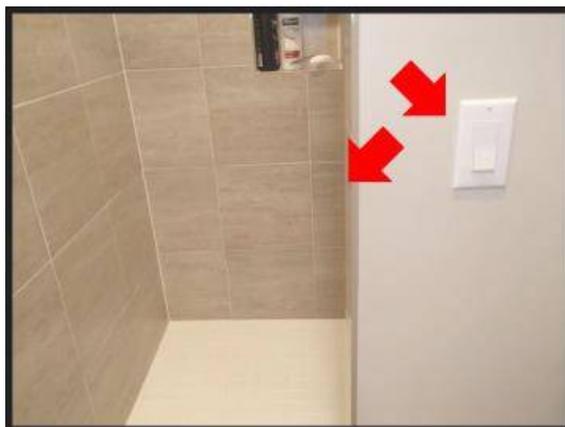
The light switch is located too close to a source of water and this should be corrected for safety.

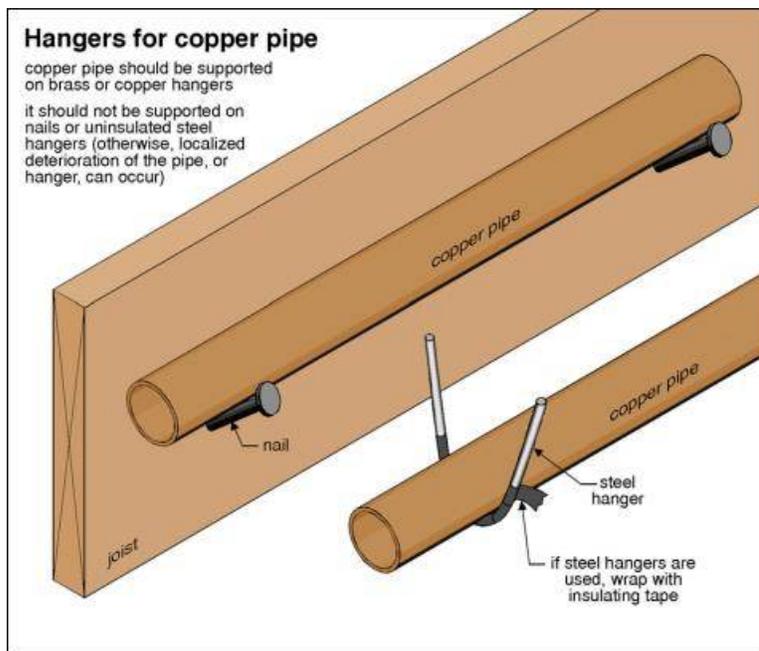
The copper water supply lines should be supported with non-metallic or compatible metal straps to prevent corrosion.

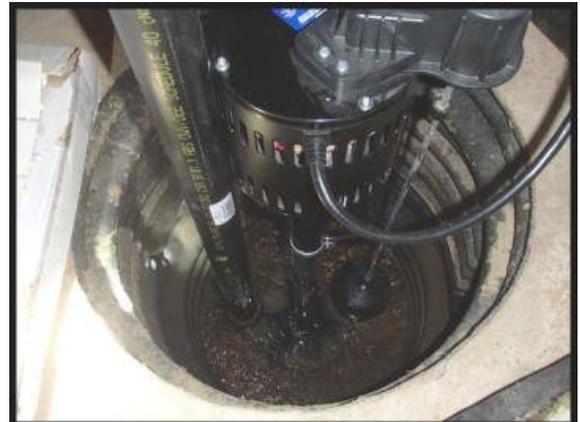
The sump pump is functional. However for safety and to control moisture, a cover is required over the sump pit.

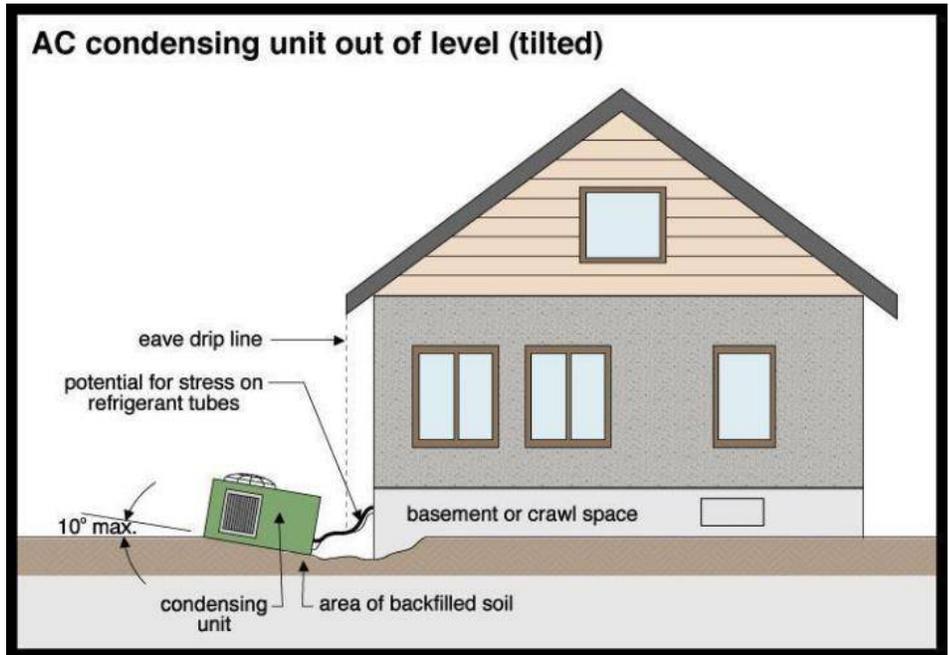
The air conditioner requires leveling in order to function as designed.

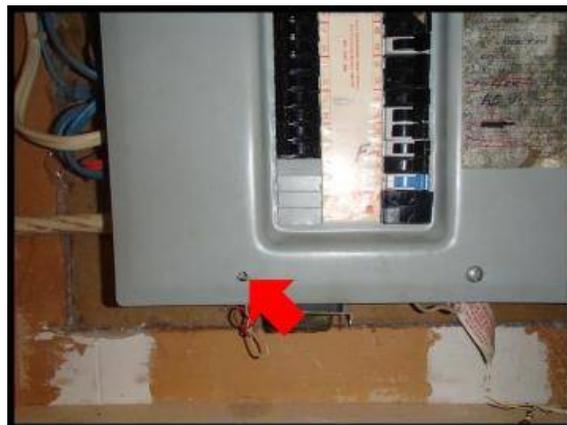
The panel cover requires proper and/or additional fasteners.

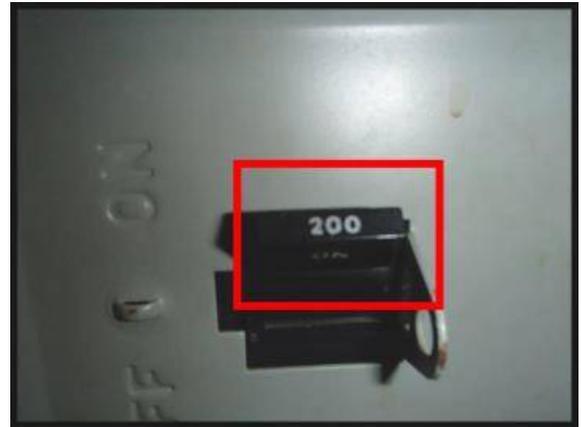
Size: The house appears to be serviced by a 200-amp service panel with 120/240-volt circuits.

A tie bar is missing and this should be corrected for safety. A tie bar is required so when a circuit breaker trips during an overload, the connected circuit breaker will also trip ensuring that no power remains to the fixture or appliance.

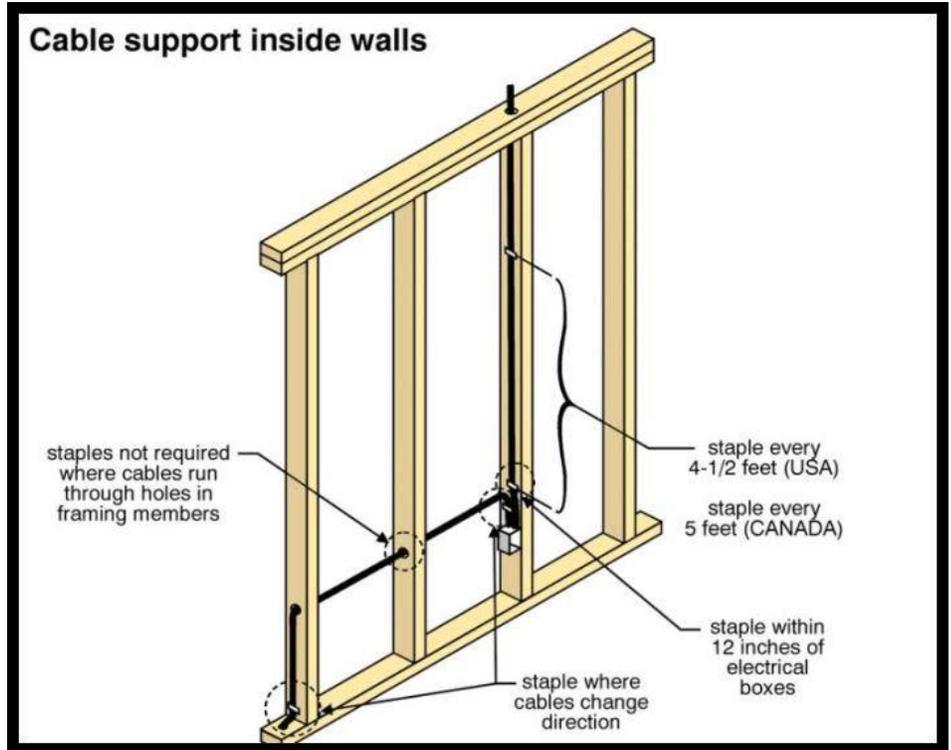
For safety, some of the visible electrical cables should be properly stapled/fastened in place.

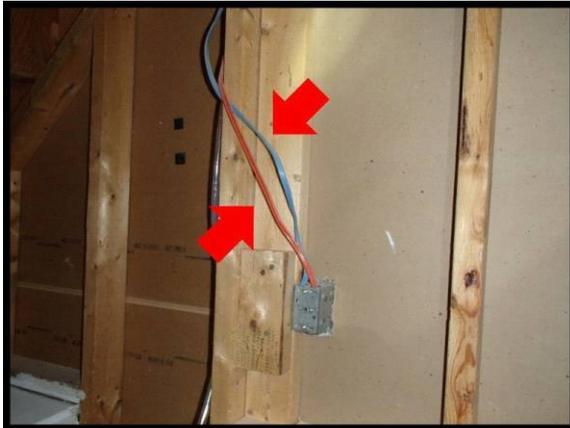
cables require securing

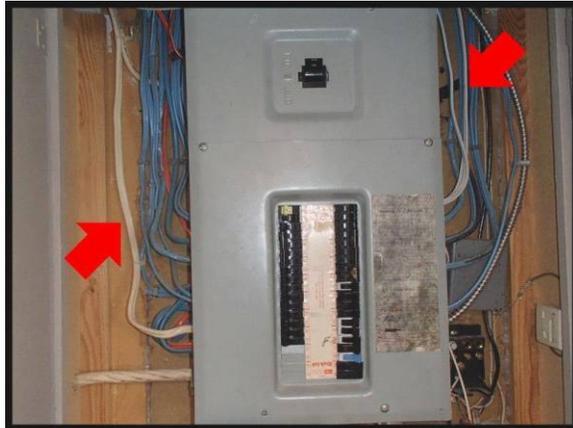
cables require securing

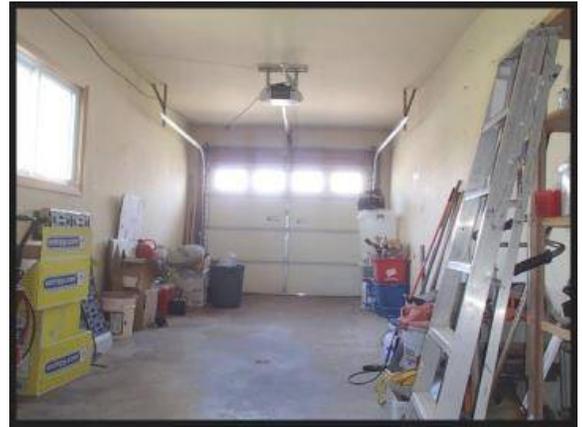
Observations: The inspection of the garage was impaired due to all the items stored in the garage. Therefore the condition of these areas is excluded from this report.

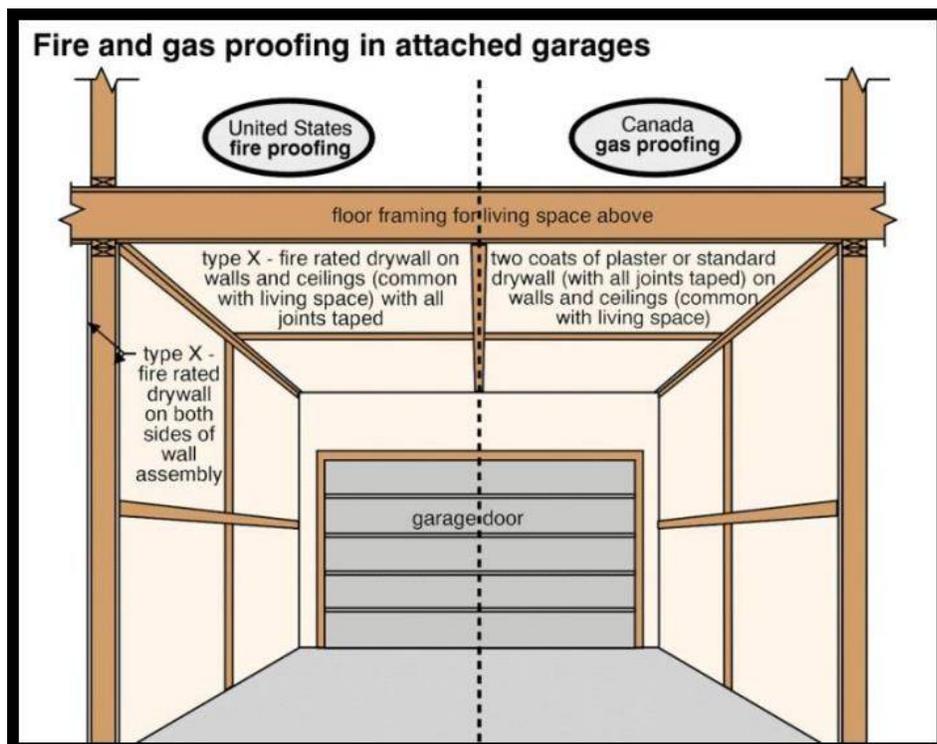
For safety, all openings in the separation wall should be repaired/sealed with approved materials in order to have a proper separation between the garage & the dwelling and to deter potentially hazardous gases from entering the dwelling.

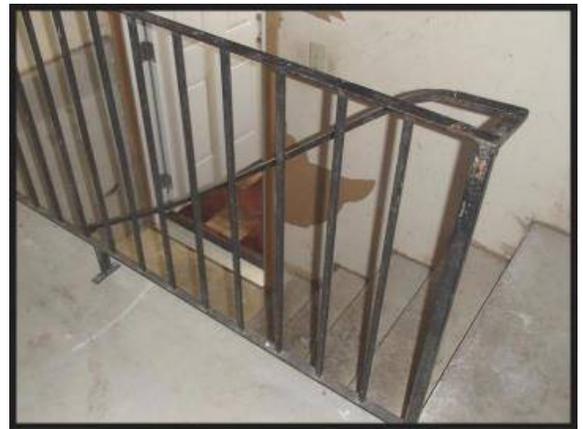
The retaining wall is generally in fair condition. The below grade steps are in fair condition. The handrail to the below grade steps is in fair condition. The railing is in fair condition.
